Debris/Ice/TPS Assessment and Integrated Photographic Analysis of Shuttle mission STS-105

**DEBRIS/ICE/TPS ASSESSMENT and
INTEGRATED PHOTOGRAPHIC ANALYSIS
OF SHUTTLE MISSION STS-105**

Armando Oliu
Process Engineering/Mechanical System Division/ET-SRB Branch,
Kennedy Space Center, Florida

August 10, 2001

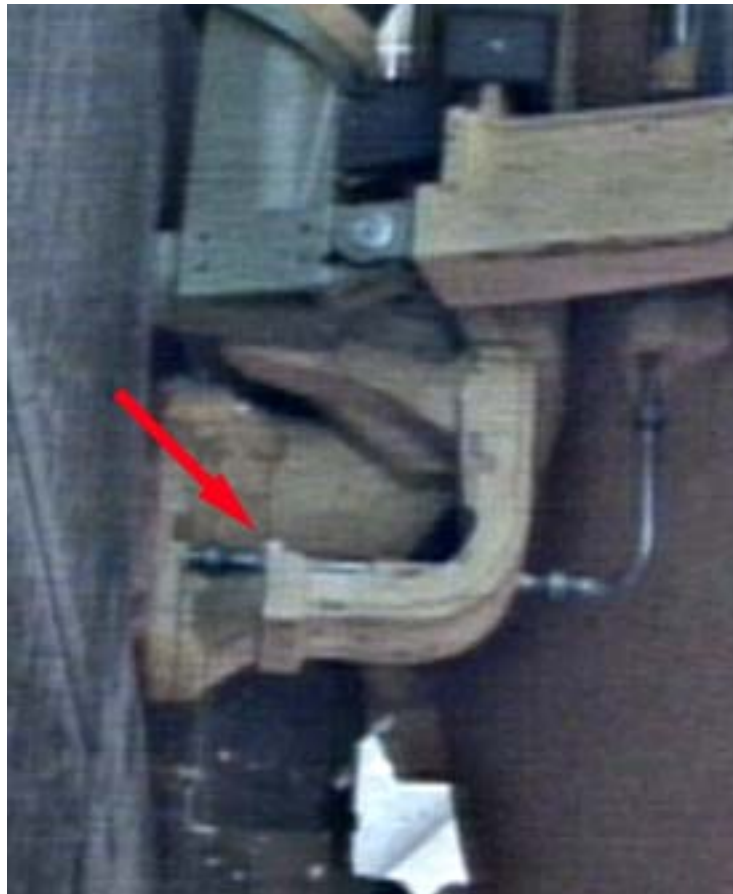
Figure 2.2.1 (A) Ice Contacts LH2 Cable Tray (Camera OTV054)

Multiple pieces of ice debris were seen falling from the ET/Orbiter umbilicals and along the $-Z$ side of the body flap during SSME ignition through liftoff. Two pieces of umbilical ice debris were seen to contact the LH2 umbilical well door sill during SSME ignition (21:10:09.825 UTC and 21:10:14.596 UTC). A single piece of umbilical ice debris from the forward (+X) surface of the ET / Orbiter LO2 umbilical fell aft and contacted the +X surface of the LO2 electric cable tray (21:10:10.793 UTC). See Figure 2.2.1 (A). No damage to the launch vehicle was detected. Umbilical ice debris contacting the Orbiter surfaces has been seen on previous missions. (Ice from the forward (+X) side of the LH2 ET / Orbiter umbilical well was seen falling past the LH2 four inch recirculation line, but no contact with the launch vehicle was noted.) (Cameras OTV009, OTV054, OTV061, OTV063, E4, E5, E17, E18, E19, E20, E31, E63)

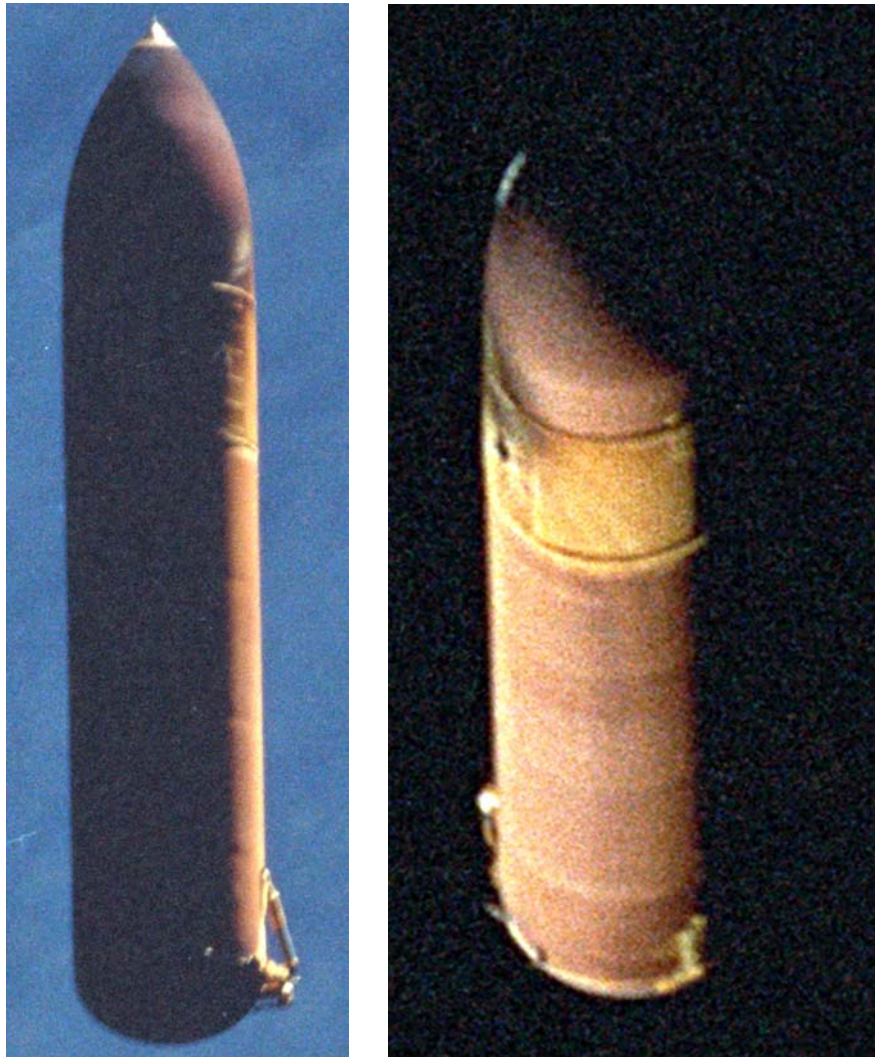
Figure 2.3.3 Crew Handheld Images of the External Tank (frames 6 and 13)

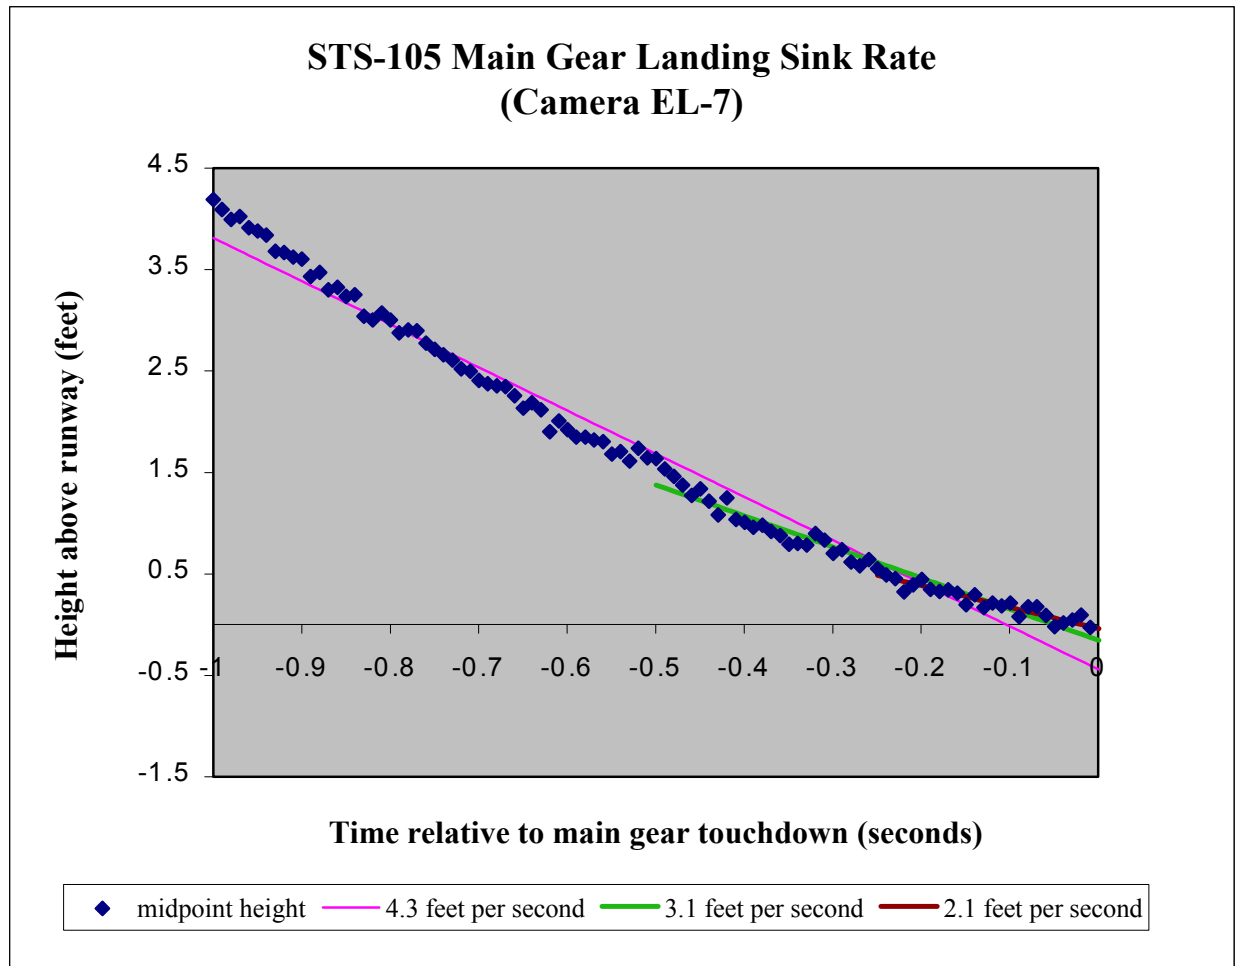
Figure 2.5 Main Gear Midpoint Landing Sink Rate

The maximum allowable main gear sink rate values are 9.6 feet / second for a 212,000 lb. vehicle and 6.0 feet/second for a 240,000 lb. vehicle. The landing weight of the STS-105 vehicle was reported to be 222,275 lbs.
